EVALUATION OF SAMPLE HELICOPTER
TAIL ROTOR PITCH LINK BEARINGS BY
DYNAMIC TESTING USING SIMULATED
LOAD/MOTION CONDITIONS

FRC Report P253

December 3, 1992

Naval Air Development Center
Warminster, PA 18974-5000

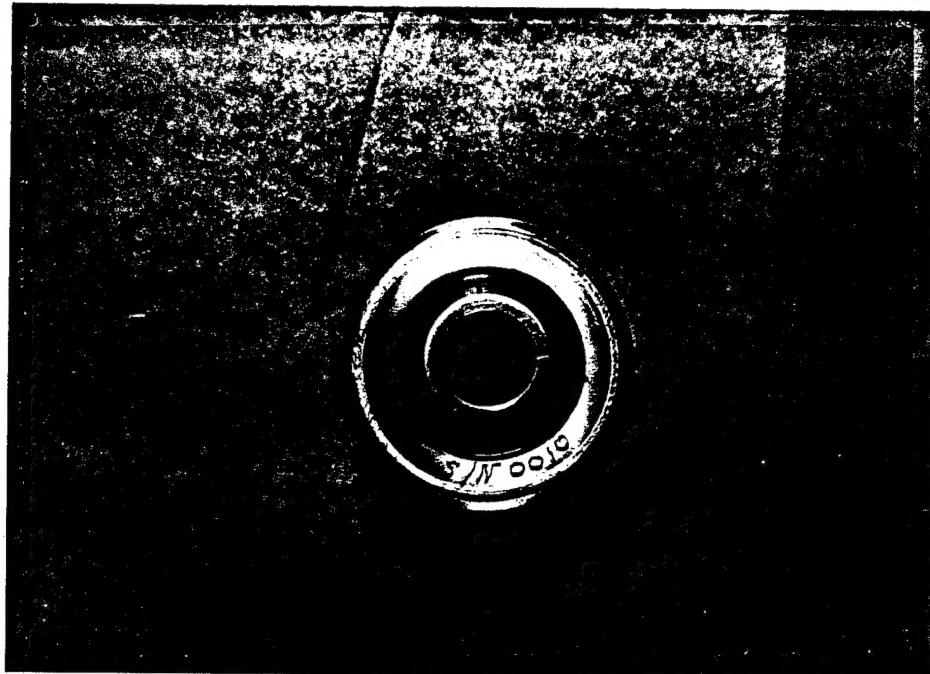
Figure 1. Typical Test Bearing Before Being Pressed Into Housing.

- A. Two of the twelve bearings (starting with Serial Number 0001 and 0002) were pressed into heat treated steel housings with a 0.0005 to 0.0015 inch interference fit. Figures 1 and 2 show a bearing before and after it is pressed into a housing.

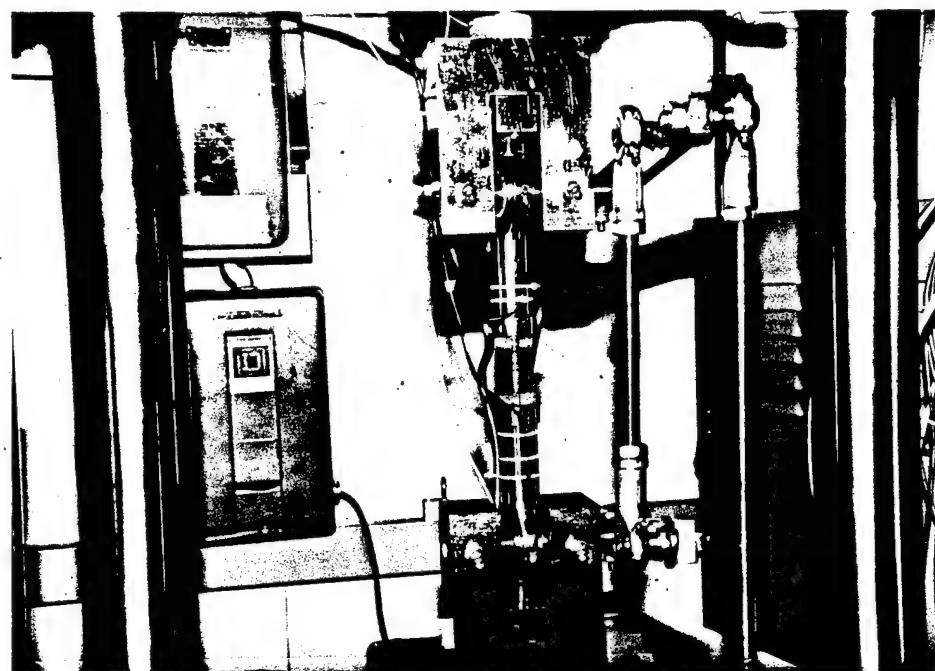
Figure 3. Overall View of Assembly Installed in the Test Machine.

- D. A tie rod was used to connect the two clevises together as an assembly. This assembly was then installed in the Instron test machine.
- E. Crank arms were connected to the bearing shafts and to a connecting rod, which was driven by an electric motor crank. An overall view of the assembly installed in the test machine is presented as Figure 3.

Copper tubes (1/4 inch size) shown in the photo of Figure 3 are water contamination lines terminated above both sides of each test specimen. The lines were connected to a metering apparatus which allowed approximately 30 ml per hour of distilled water to flow over the test specimens. A solenoid controlled valve gravity fed system was operated for six hours of each working day that a test run was in progress.

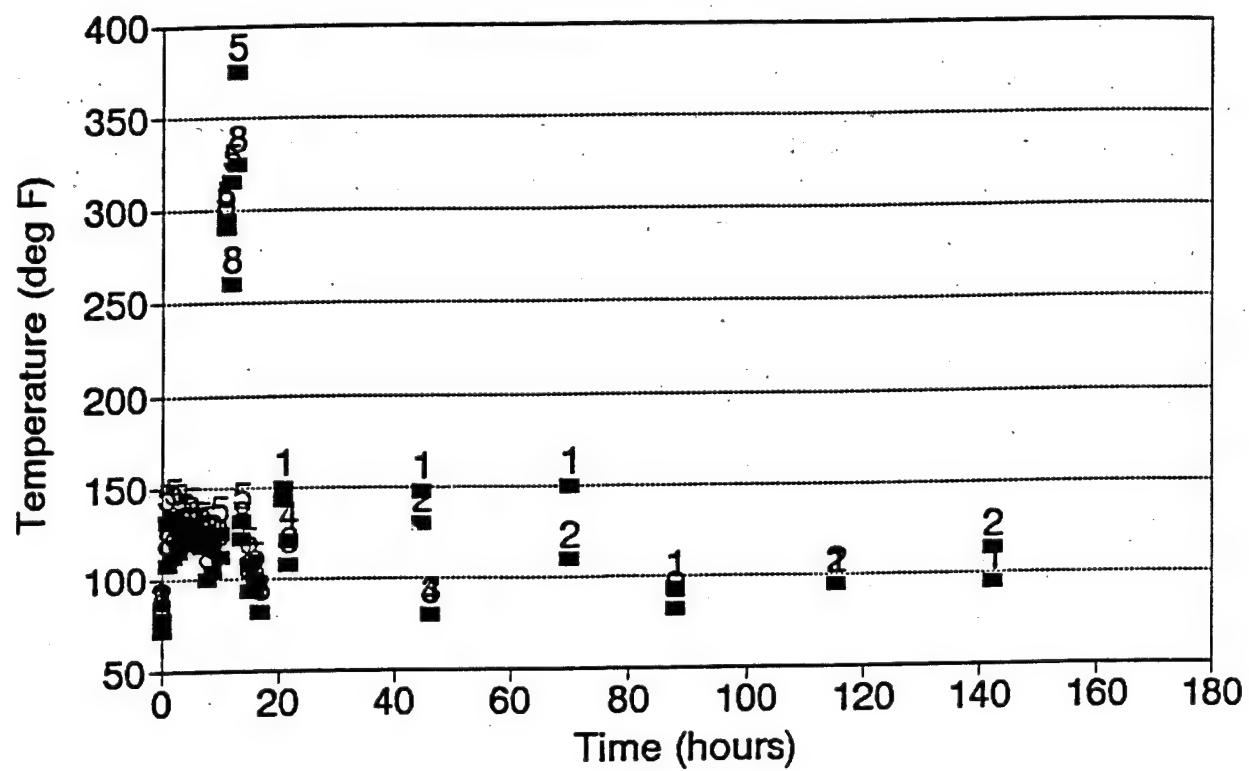
Figure 6. Graph of Temperature vs Time for Failed Bearings.

Figure 6 is a temperature vs time graph for bearings 0001-0004, 0005, and 0008, showing all bearings failing prematurely. Bearings 00797 and 01893 of test run number three were combined with the failed bearings and graphed as Figure 7.

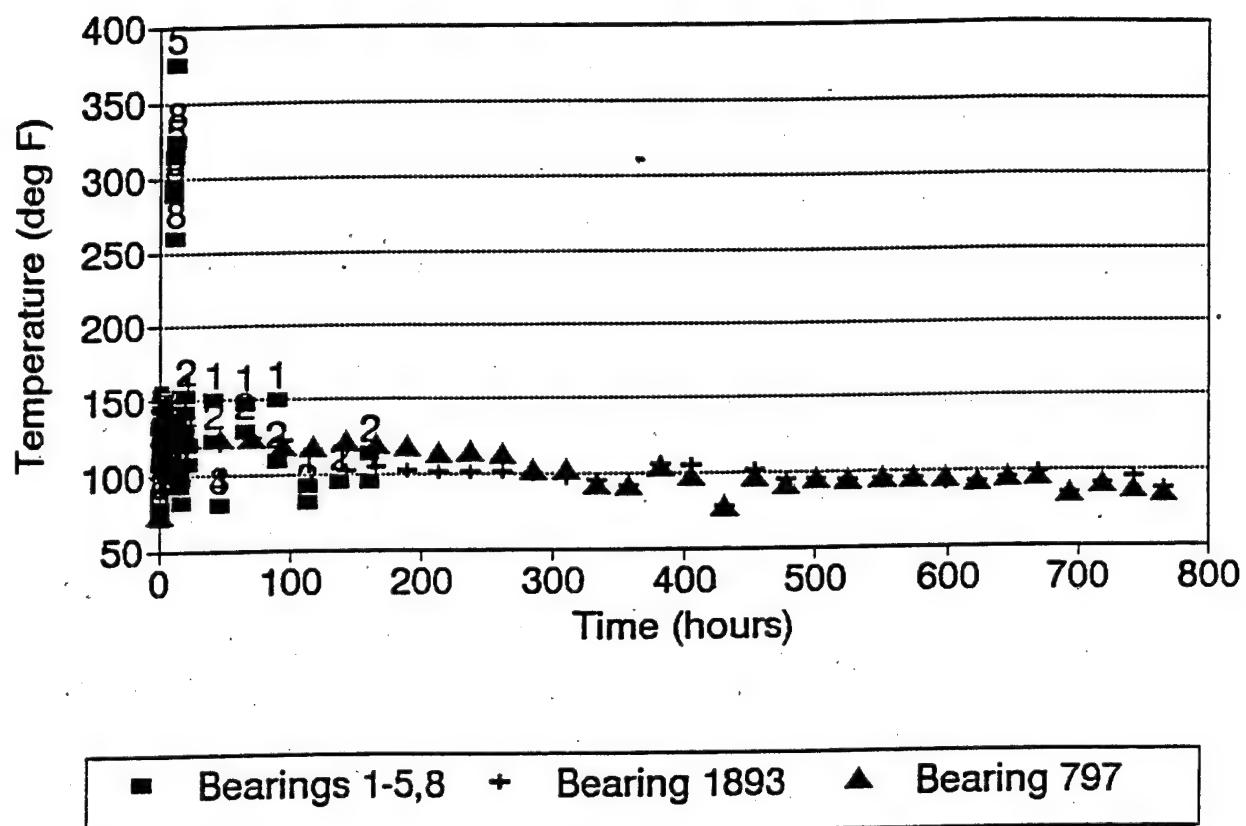
Figure 7. Graph of Temperature vs Time for Failed Bearings and Successfully Tested Field Bearings.

Two distinct trends can be noticed from the data. The first trend shows low failure times for bearings 0001, 2, 3, 4, 5, and 8. None of these bearings exceeded 143 hours before failure. They were expected to last 800 hours. The second trend shows no failure for bearings 00797 and 01893. Both are of the bearing type in field use.

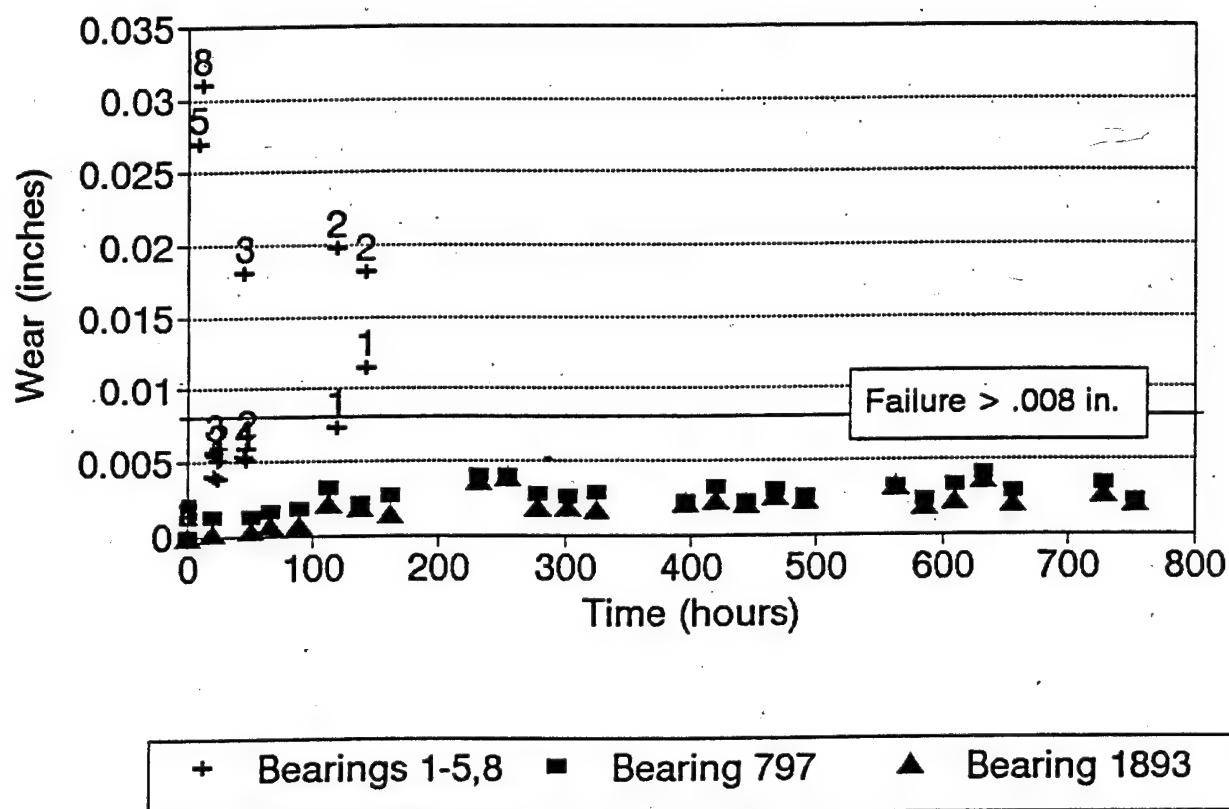
Figure 8. Graph of Bearing Wear vs Time for Failed and Successfully Tested Bearings.

After the bearing tests were completed, the test data tabulated in Tables 1 to 4 and plotted in Figure 8 were analyzed. Bearings 0001-5 and 0008 were part of the original study. Bearings 00797 and 01893 were submitted by NADC when short failure times were noticed on the initial tests. A failure line of .008 inches is indicated on the graph. The time required for a bearing to wear this amount is the failure time.

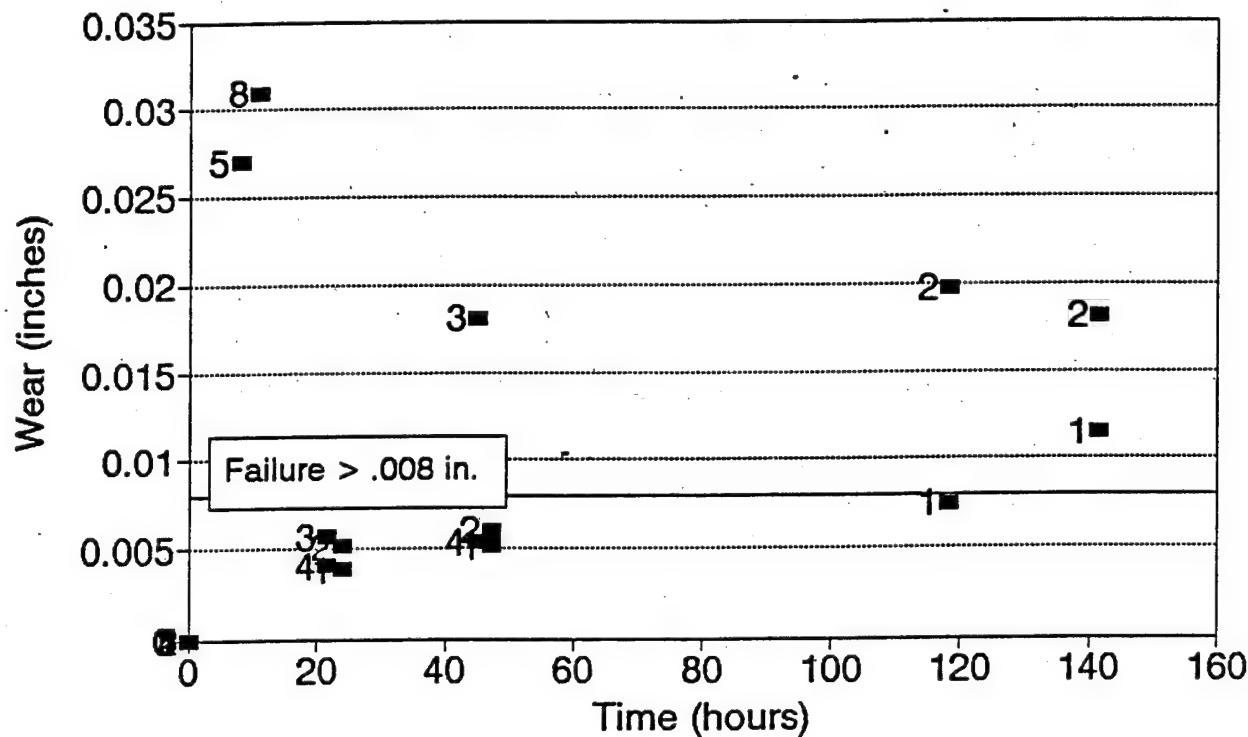
Figure 9. Graph of Bearing Wear vs Time for Failed Bearings 1-5 & 8.

A graph isolating the failed bearing data is shown in Figure 9. This graph highlights the wide variation in failure times among the failed bearings. This wide variation limits the usable information from the Weibull and statistical analyses.

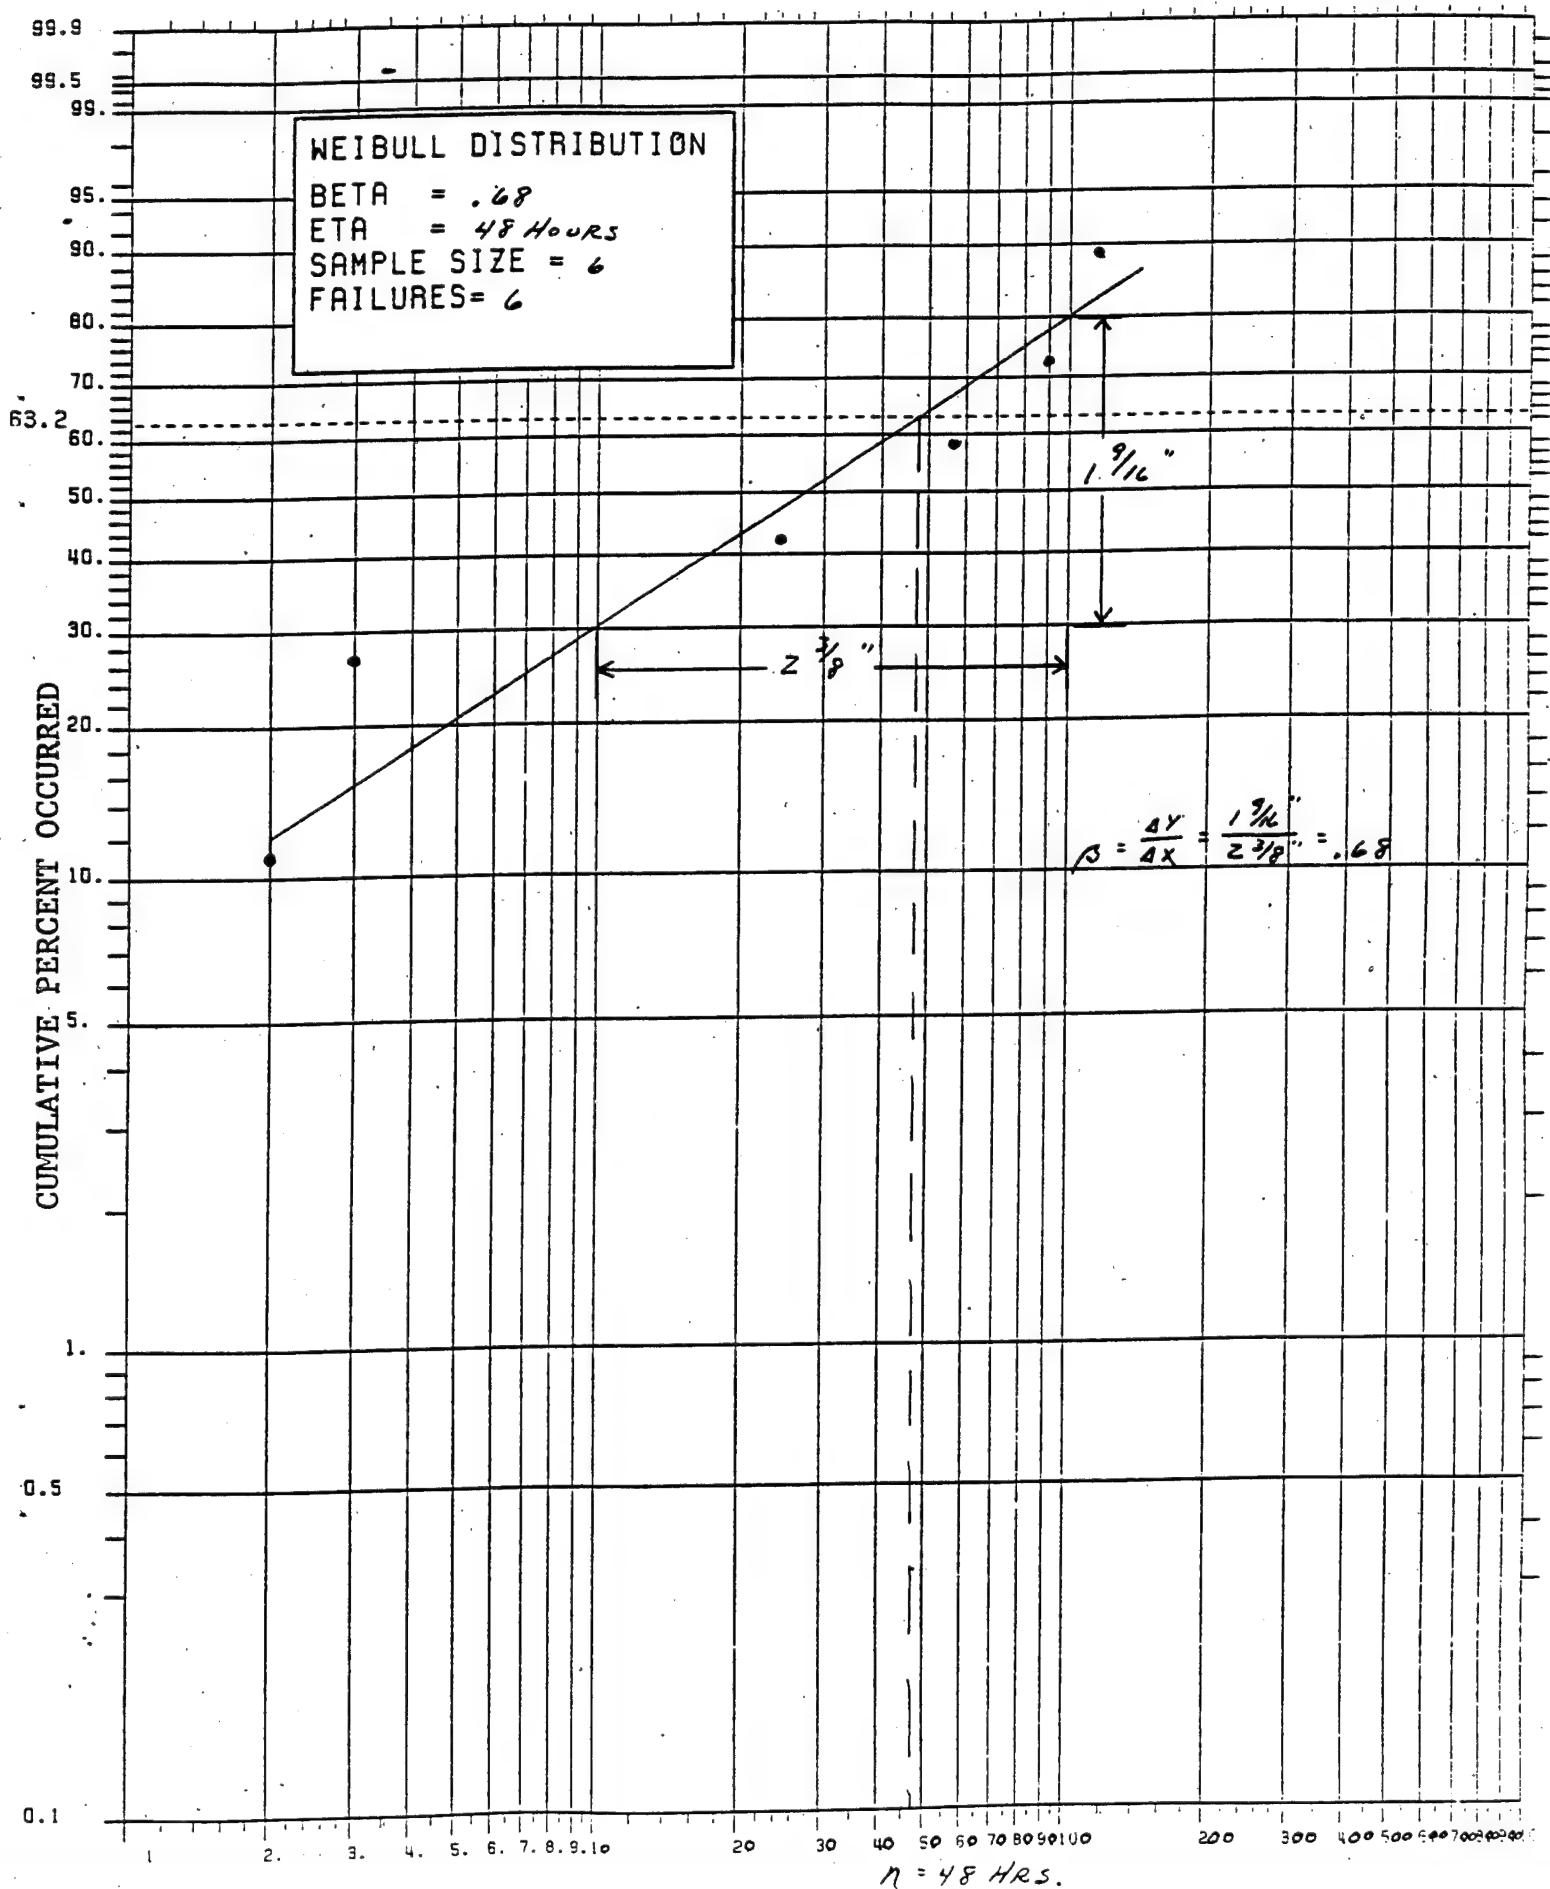
Figure 10. Weibull Graph of Bearing Failure Data.

A straight line approximation was used to obtain the slope of the Weibull line. This was determined to be 0.68, indicating infant mortality for all the failed bearings (Weibull Analysis Handbook, AFWAL-TR-83-2079, p. 22). The life expectancy (Eta) is determined to be 48 hours.

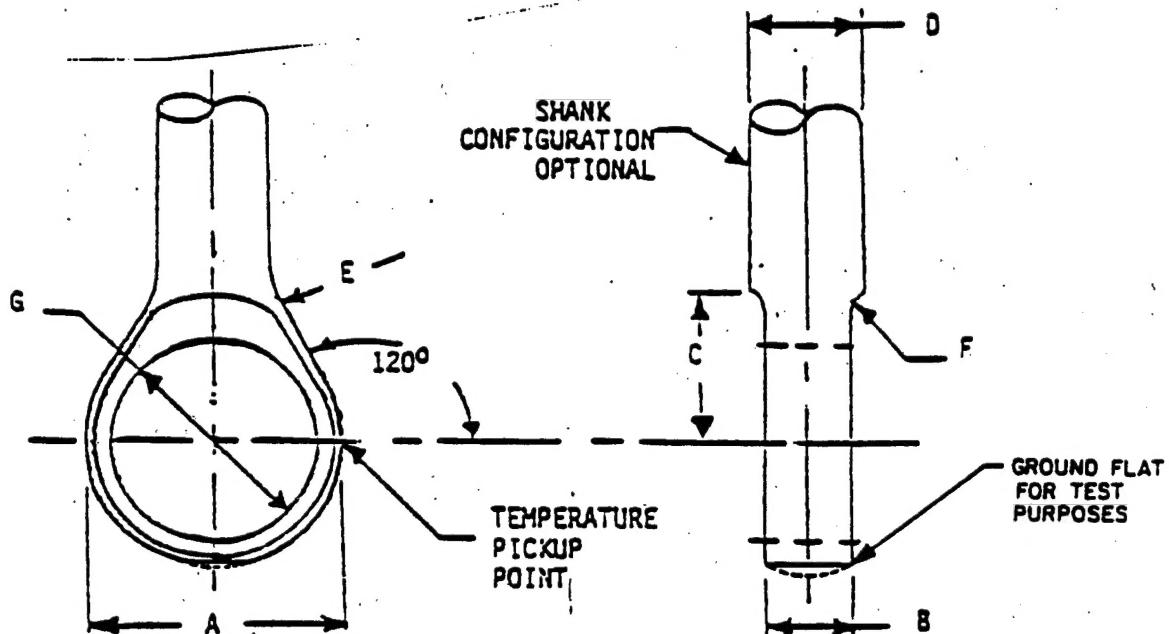
FIGURE 1. Bearing Housing Dimensions

3.2.2 Cyclic Load Oscillation Wear Tests. The bearing shall be installed in a heat treated steel housing (see Figure 1) with a 0.0005 to 0.0015 inch interference fit. The bearing outer ring side face shall be indelibly marked or engraved at the maximum load location to facilitate accurate wear measurement after removal from the test machine. A standard close tolerance aircraft bolt or pin (125,000 psi minimum) shall be used as a shaft for the bearing. The clearance between the bearing I.D. and bolt (or pin) shall not be greater than 0.0015. The bearing shaft shall be placed in double shear with a minimum of bending and shall be so assembled and secured as to assure that during the test all relative motion shall be between the ball and the outer ring.
